Manhole Inspection Summary

Manhole # S57K__026MH

Insp Date: **5/14/08 3:00 PM**

Location Address: **703 fagley st**

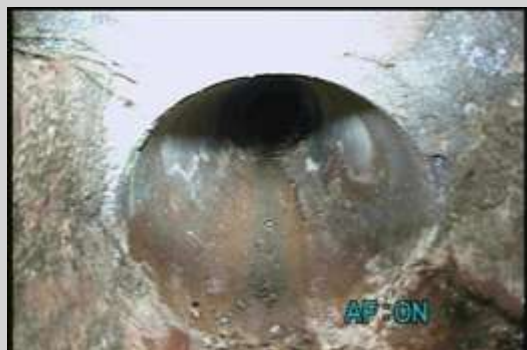
12 O'Clock Outflow

8 in. Circular Gravity Sewer
Pipe Out @ 12 O'Clock
